ALBARRIE GEOCOMPOSITES

# REMEDICATION CASE - MINOR SPILL

## TRANSFORMER SUBSTATION

Minor Spill Case  
SorbWeb Plus  
85 Morrow Rd,  
Barrie, On.

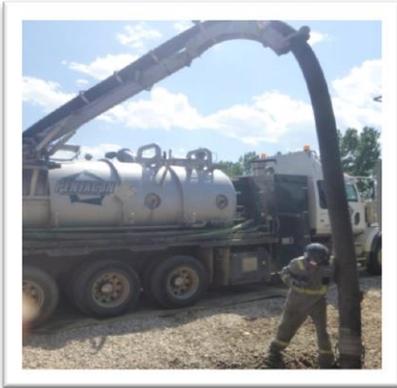
The top layer of surface/fire quenching stone was removed by Hydrovac truck (left). Some areas were dug by hand (right).

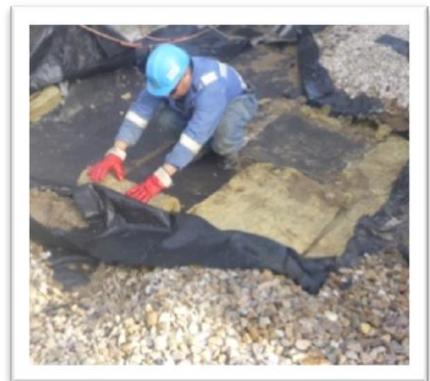
Woven geotextiles and sand were removed. The Absorbent layer was rolled up and placed in plastic bags for disposal (right).

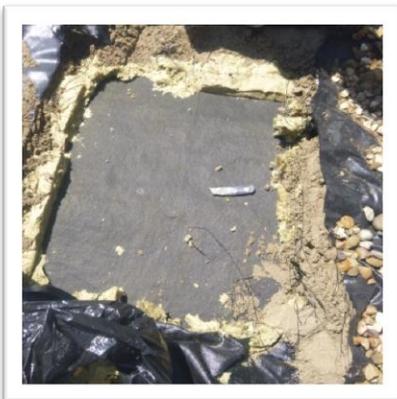
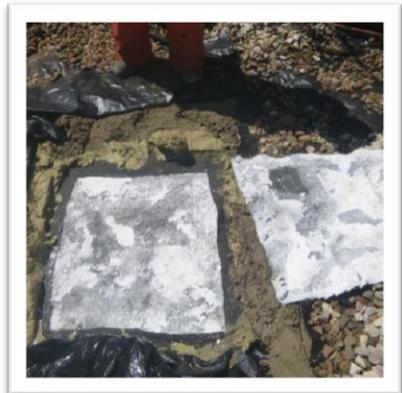
The Non woven layer also showed signs of oil penetration in this area and was cut out (left), and turned over (right).

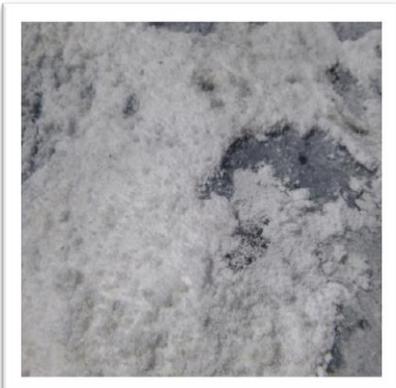
The surface of the Albasorb layer had noticeable gelling which indicated reaction with oil (left). However, the Albasorb was not completely saturated, and the oilmat was unaffected.

Typically, areas near the transformer pad will show signs of full depth reaction before areas near the perimeter. Unless oil was released under pressure, areas near the outer perimeter are not as affected.

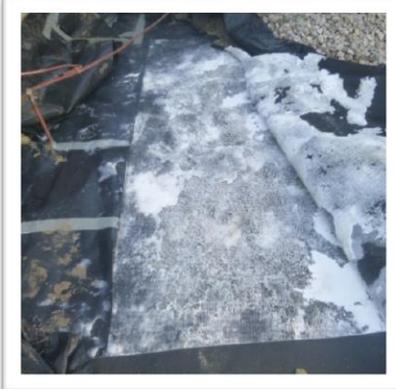
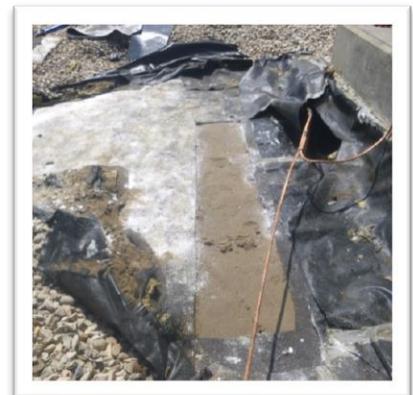
An area near the transformer pad showed signs that the Albasorb had reacted fully and oil had reached the surface of the oilmat (left).

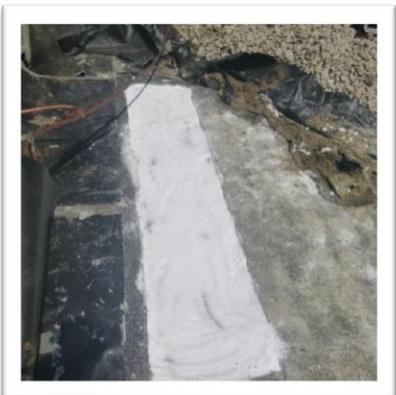
A small section of the oilmat was cut out, which revealed the underlying sand layer remained unaffected by oil (right).
