CASE STUDY

SorbWeb™ Plus
Secondary Oil Containment System by Albarrie

Electrical Substation Successfully Adds A Secondary Oil Containment System.

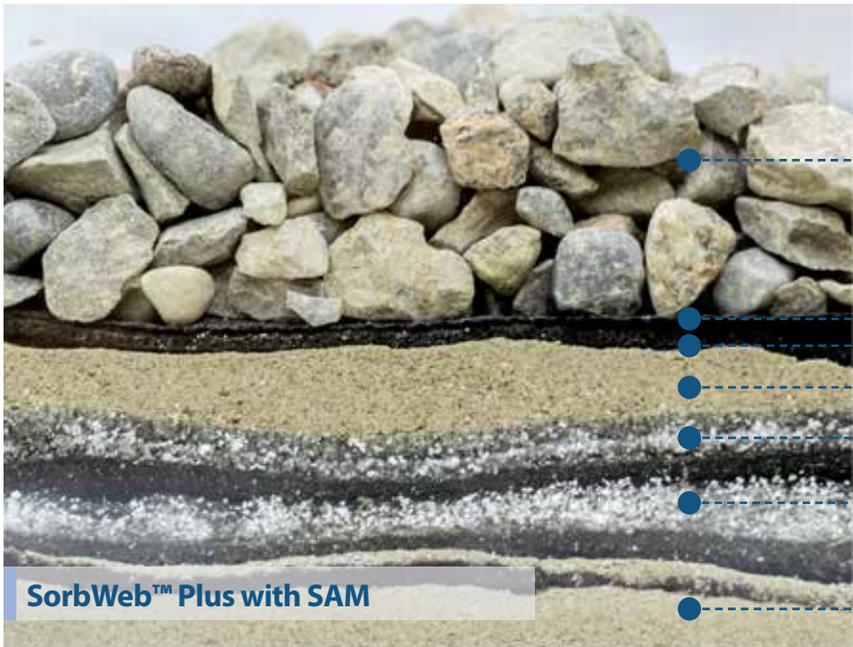
Layer 1: Fire Quenching Stone

Layer 2: Woven Fabric

Layer 3: Nonwoven Fabric

Layer 4: Sand

Layer 5: SAM

Layer 6: Oil Mat

Layer 7: Sand

Albarrie's secondary oil containment system is an innovative, flexible, cost-effective, environmentally-friendly solution custom-designed to meet site specifications and bring companies back into environmental compliance. Albarrie's layered system captures 110% of oil volume using a smart

oil-adsorbing fabric that seals on contact with hydrocarbons. The fabric allows rainwater to pass through the containment without compromise, ensuring the soil's stability underneath. The maintenance-free design meets environmental guidelines from regulating bodies in both the US and Canada.

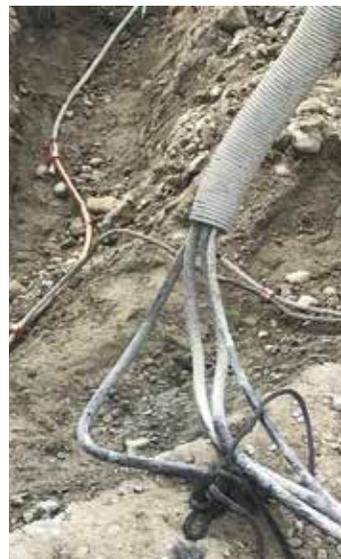
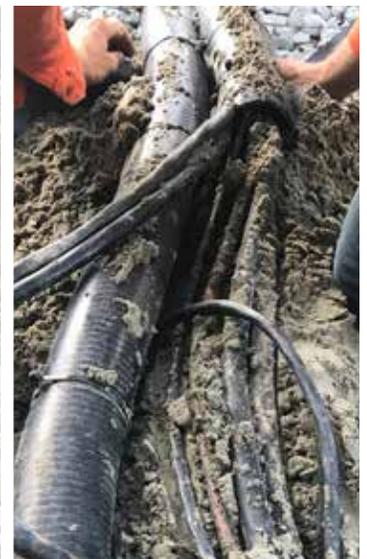
The second hurdle was the exposed direct buried underground cables. The challenge required the Albarrie team to add protection to these direct buried cables by encasing them in conduits without

moving or disconnecting them while building the containment around them.

Finally, as the **SorbWeb™ Plus** secondary oil containment excavation unfolded, Albarrie met several buried structures that required the field team to make design changes to the oil containment in real-time. The design changes accommodated the surprises while meeting the containment volume capacity requirements with minimal impact to cost.

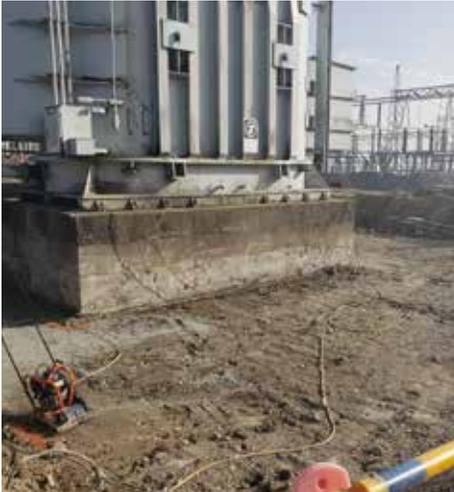
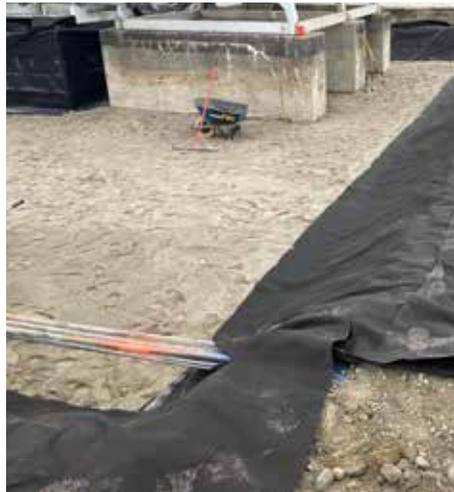
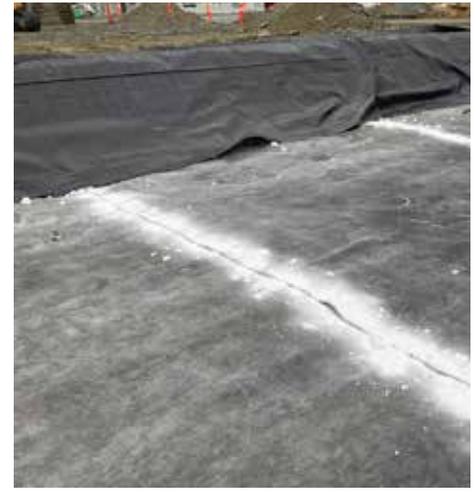
Aging equipment, along with social and governmental demands to protect the environment, requires utility companies today to address potential hazards lurking in substations, including transformers that currently have no means to contain an oil spill in case of equipment failure. The project included remediating five areas: four reactors and one transformer.

With infrastructure built 60 years ago, we never know what lies hidden beneath the surface. However, through a close working partnership, the Albarrie team and the utility company successfully brought the old substation back into compliance with modern regulations.
